Southwest Abutment & Retaining Wall Approximate Quantities

Northeast Abutment & Retaining Wall Approximate Quantities

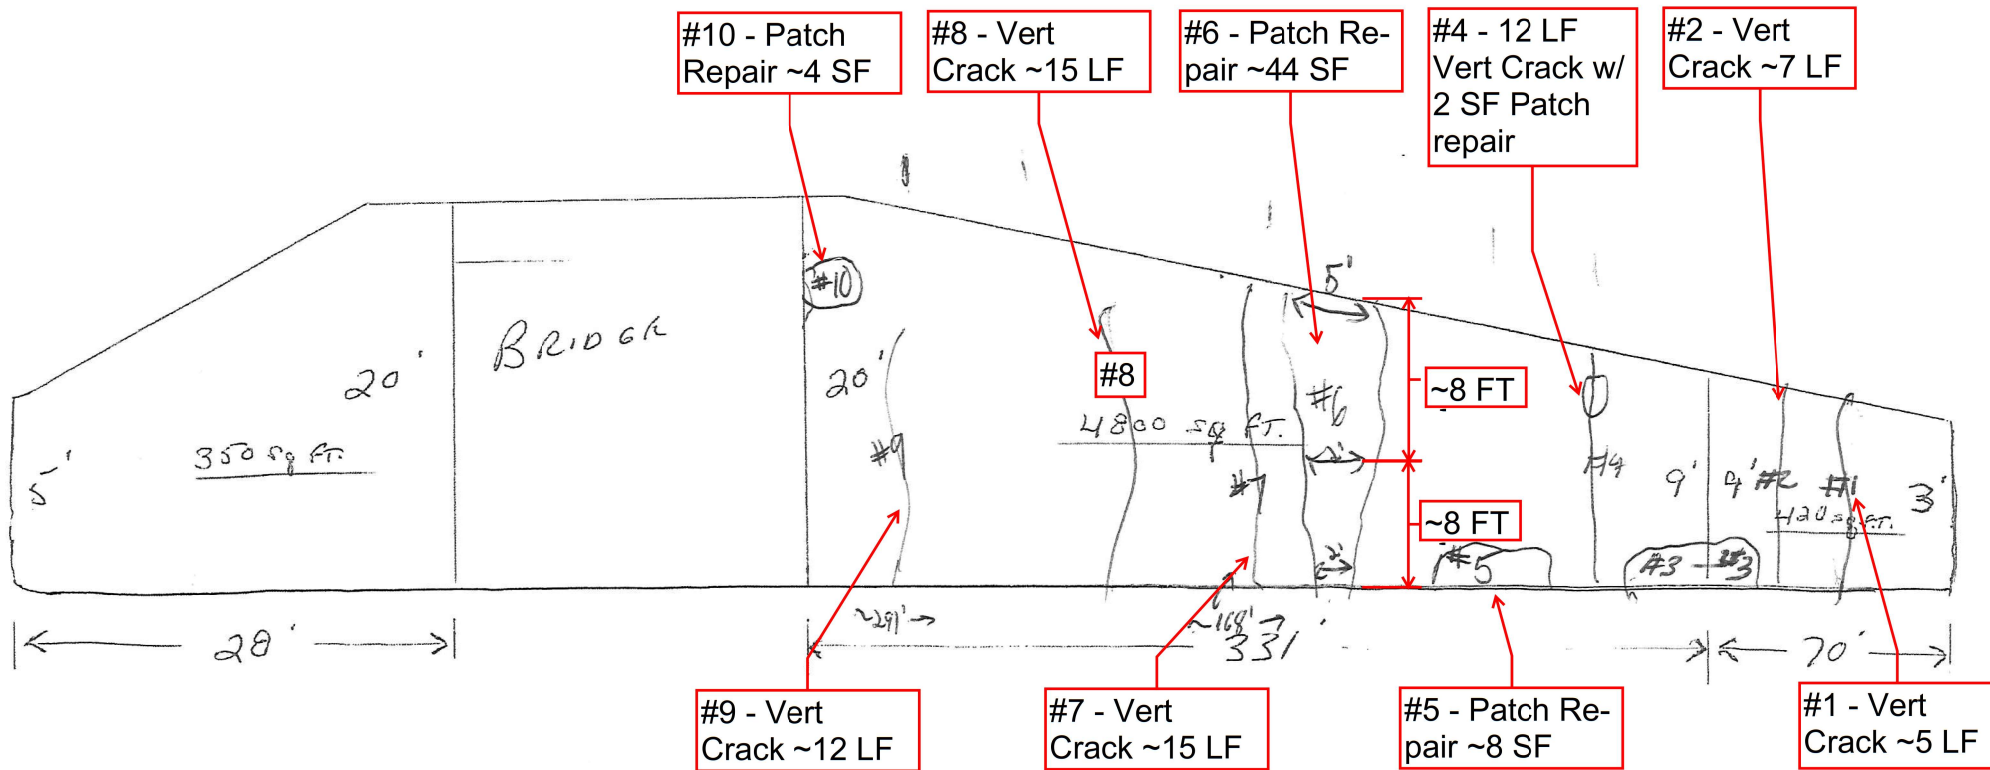
Southwest Elevation Abutment & Retaining Wall

Total LF of Crack repair: 66

Total SF of Patch Repair: 58

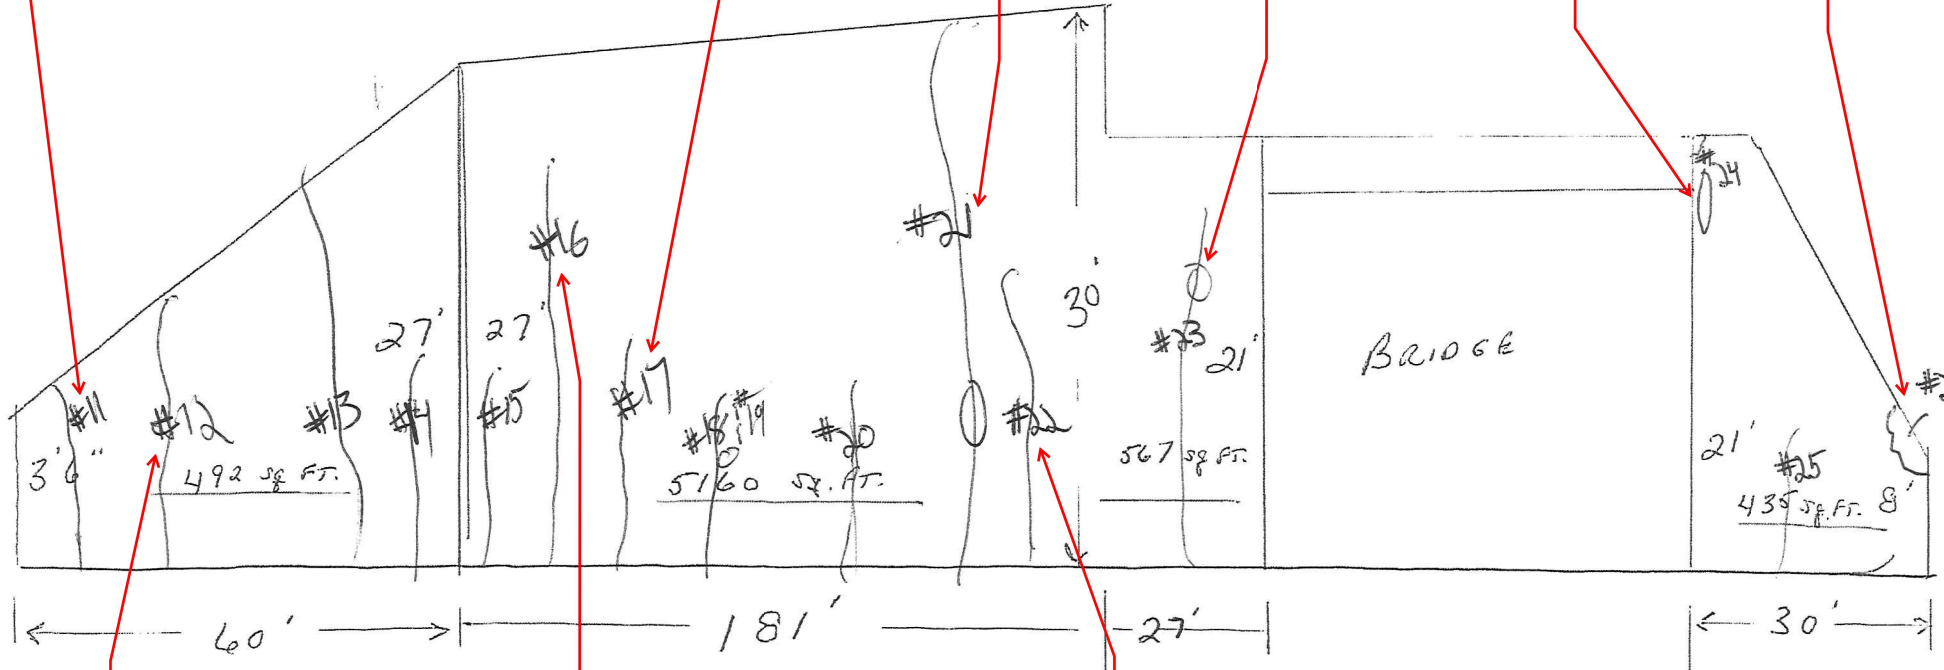
Northeast Elevation Abutment & Retaining Wall

Total LF of Crack repair: 117

Total SF of Patch Repair: 19

#11 - Vert
Crack ~7 LF

#17 - Vert
Crack ~15 LF

#21 - Vert
Crack (~29 LF)
w/ Spall (~2 SF)

#23 - Vert
Crack (~21 LF)
w/ Spall (~1 SF)

#24 - Patch
Repair ~10 SF

#26 - Patch
Repair ~6 SF

#12 - Vert
Crack ~10 LF

#16 - Vert
Crack ~20 LF

#22 - Vert
Crack ~15 LF
